TB98 Freezer Test:

April 2008

Objective: Find out what can be done to stop or reduce ice buildup on TB98 Mast and Seatrack.

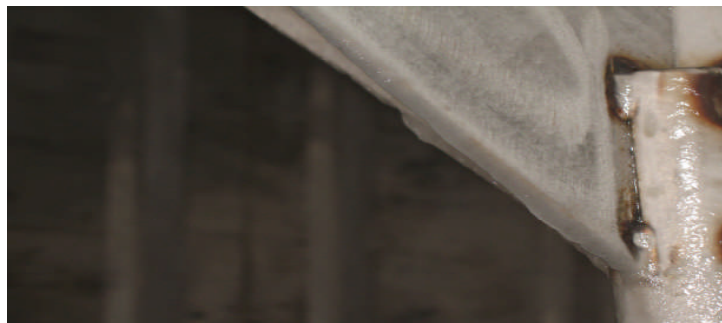
1: Stainless Steel Mast Bare from factory.

The SS mast collected ice very fast and it was not possible to get it off by hand. Accumulation was appx.

1cm over all of the steel with large ice extensions from the radar reflector and collections around joint sections.

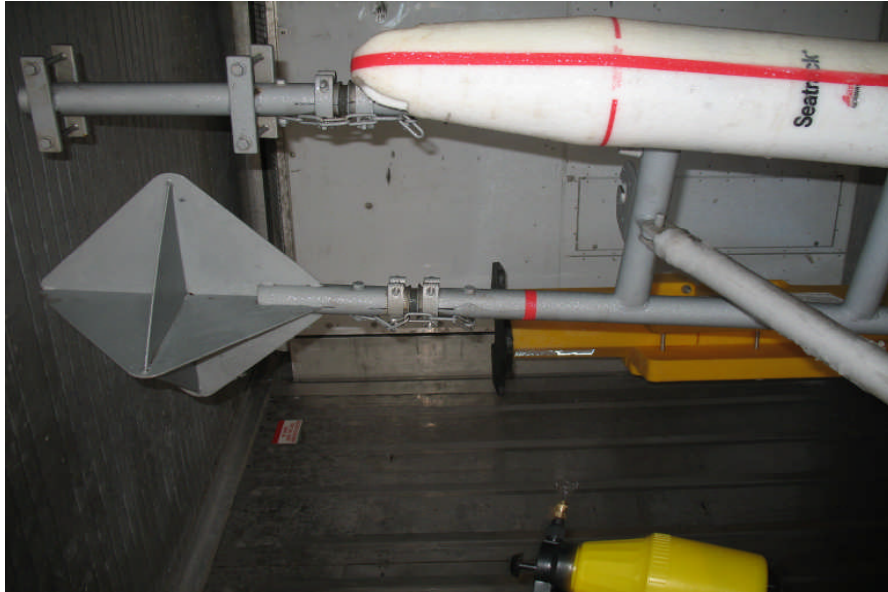
- 2: Mast with undercoat and Zyvere Coating, (used to repel water and dirt on automobiles)
Water froze on this just like the others, but there was improvement over the SS mast
It was possible to flake off bits and melting was much faster.

Two component coating from Nanovere, added protection to ice build-up.

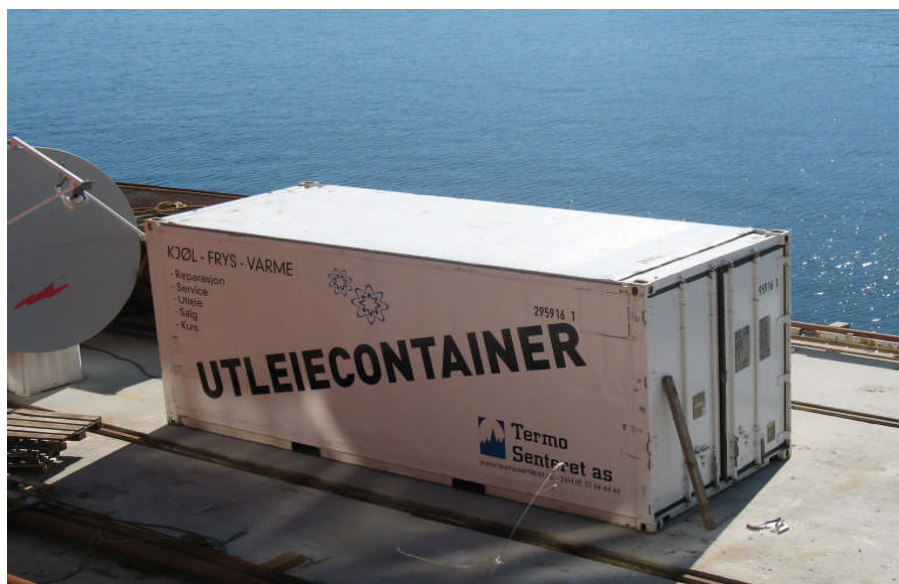
20 Ft Freezer

All test done with sea water 6 degrees C, Thermal chamber -20C, which warmed up to about -10C when we were in and spraying water. The unit had a large freezer unit and fan that moved air in the chamber.

Time to get down to -20C was about .5 hour from start up at 6C. Unit was a warm or cold chamber but we only used cold.
